WETLAND AND STREAM DELINEATION REPORT

Oneida Wind 4949 Forest Avenue, Oneida, New York LaBella Project No. 2213066

Prepared For: Borrego Solar Systems

Date: October 2021

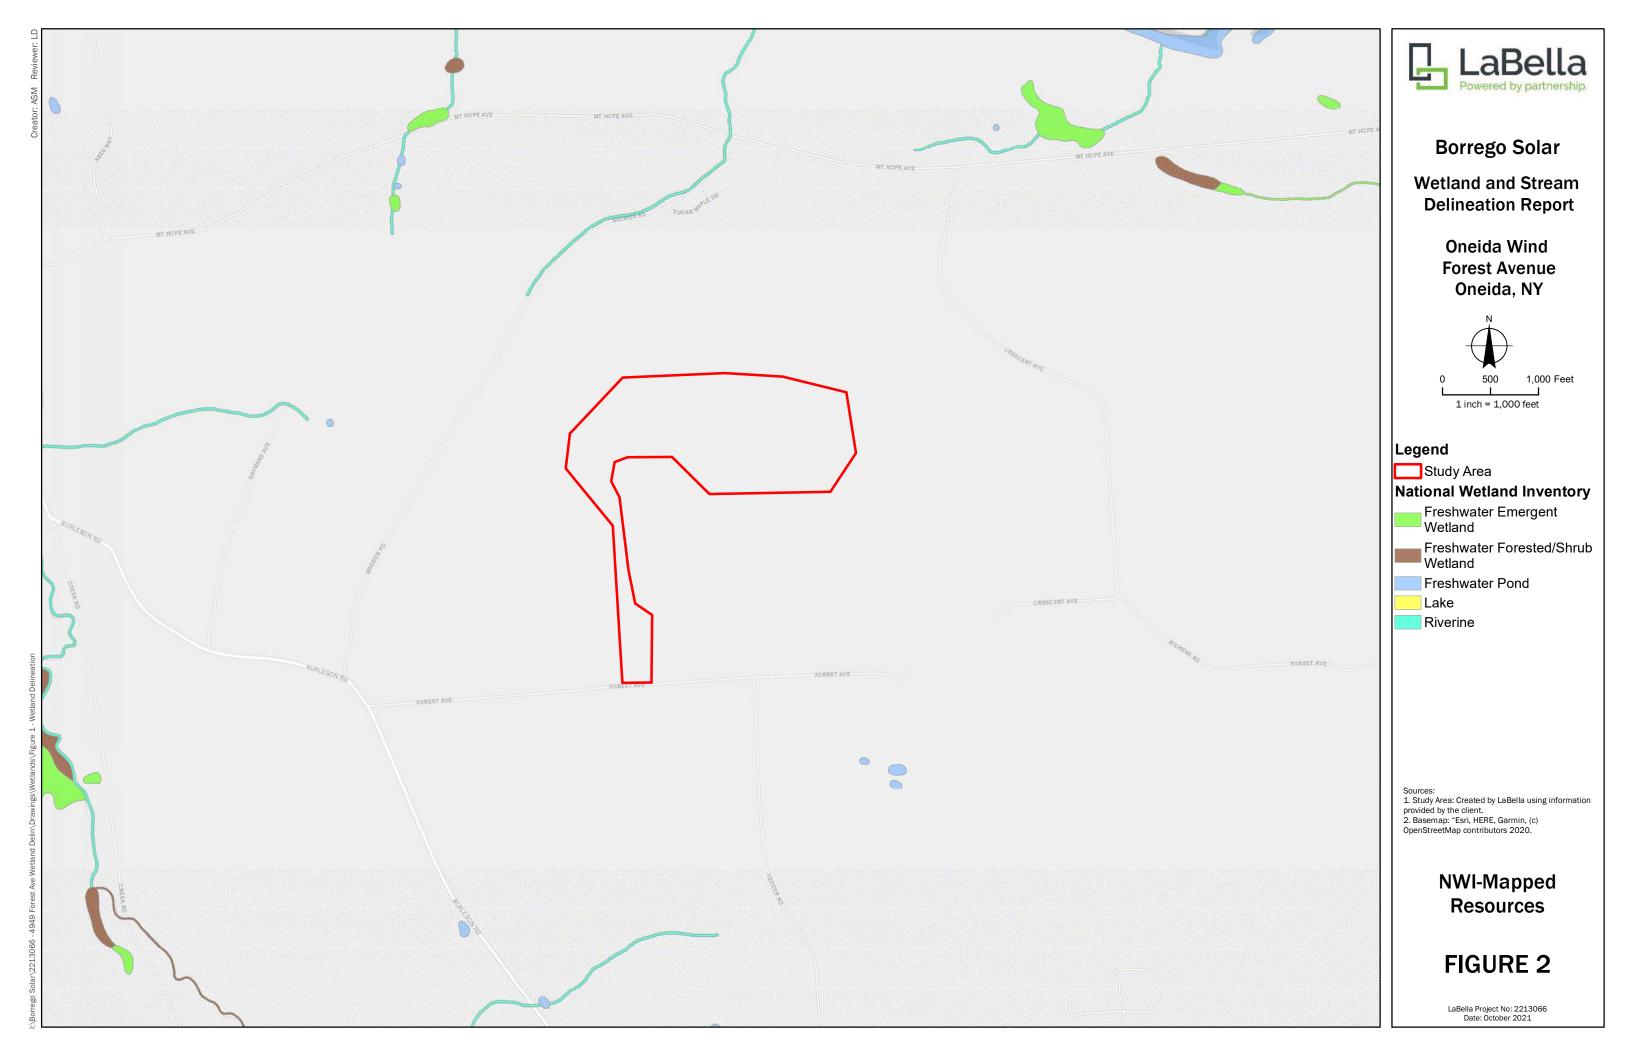
USFWS NWI mapping showed no wetlands within the Study Area (refer to Appendix A, Figure 2). The closest NWI-mapped wetland is located approximately 2,905 feet northwest of the Study Area.

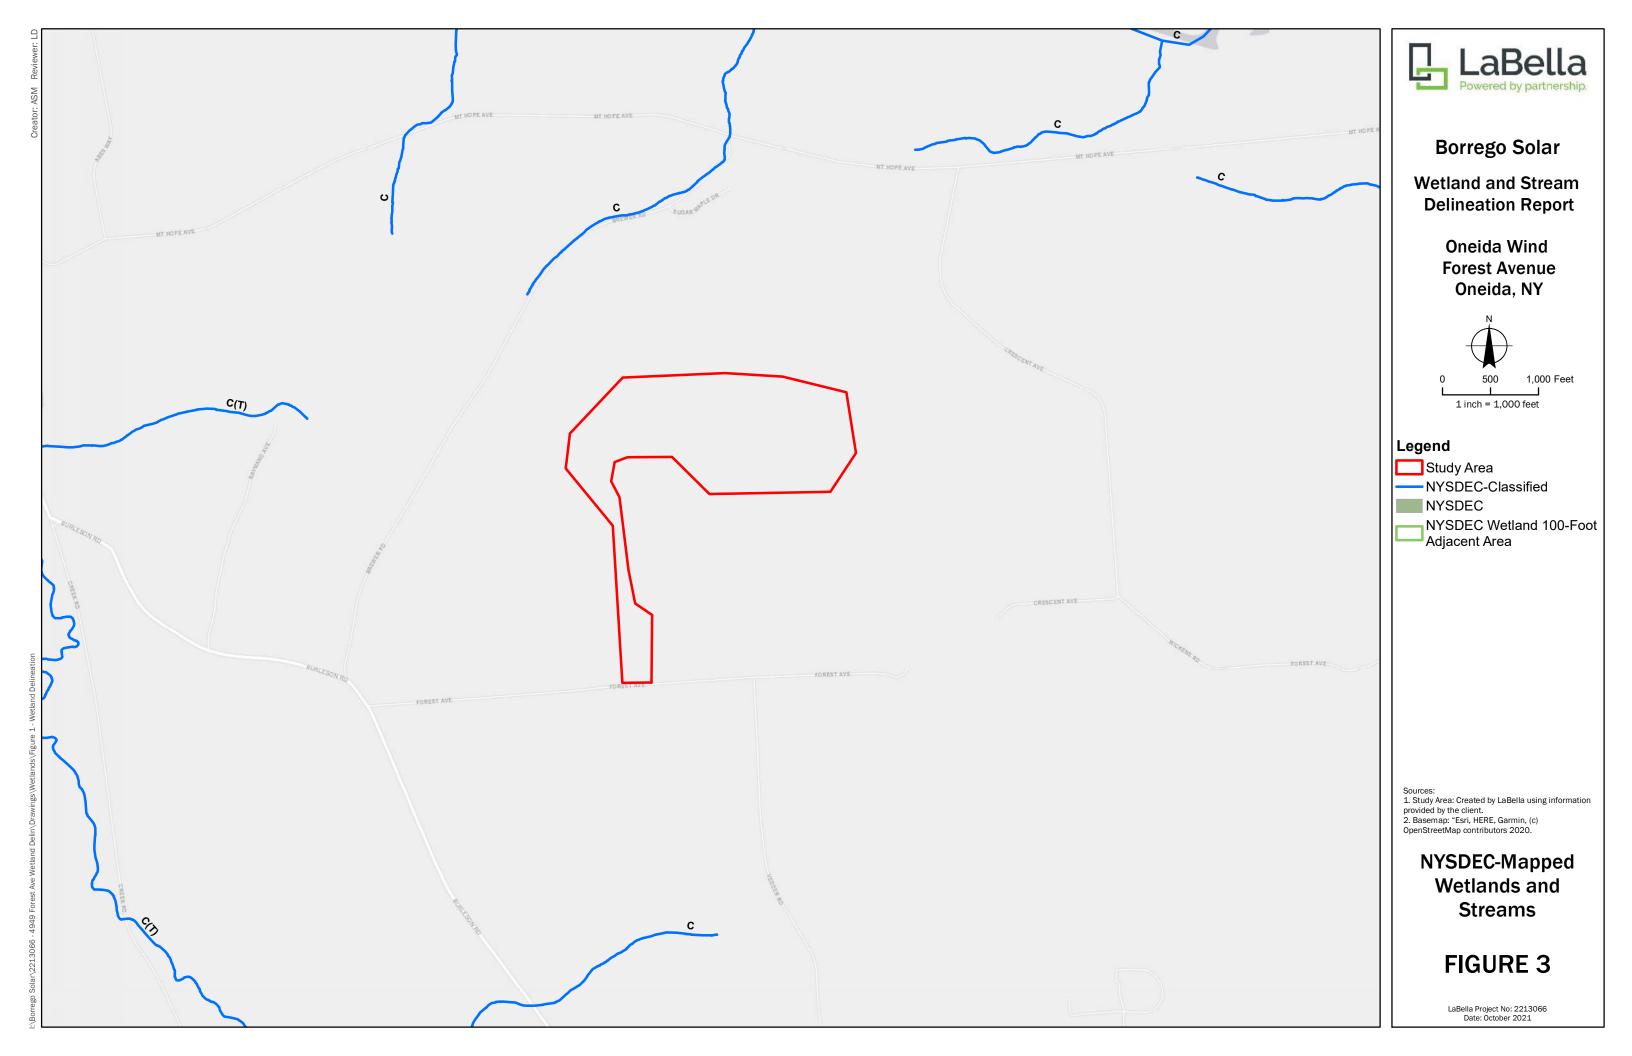
NYSDEC freshwater wetland mapping showed no State-mapped wetlands within the Study Area (refer to Appendix A, Figure 3). The closest State-mapped wetland is located approximately 10,500 feet northeast of the Study Area. NYSDEC mapping showed no streams within the Study Area (refer to Appendix A, Figure 3). The closest stream is located approximately 1,320 feet northwest of the Study Area.

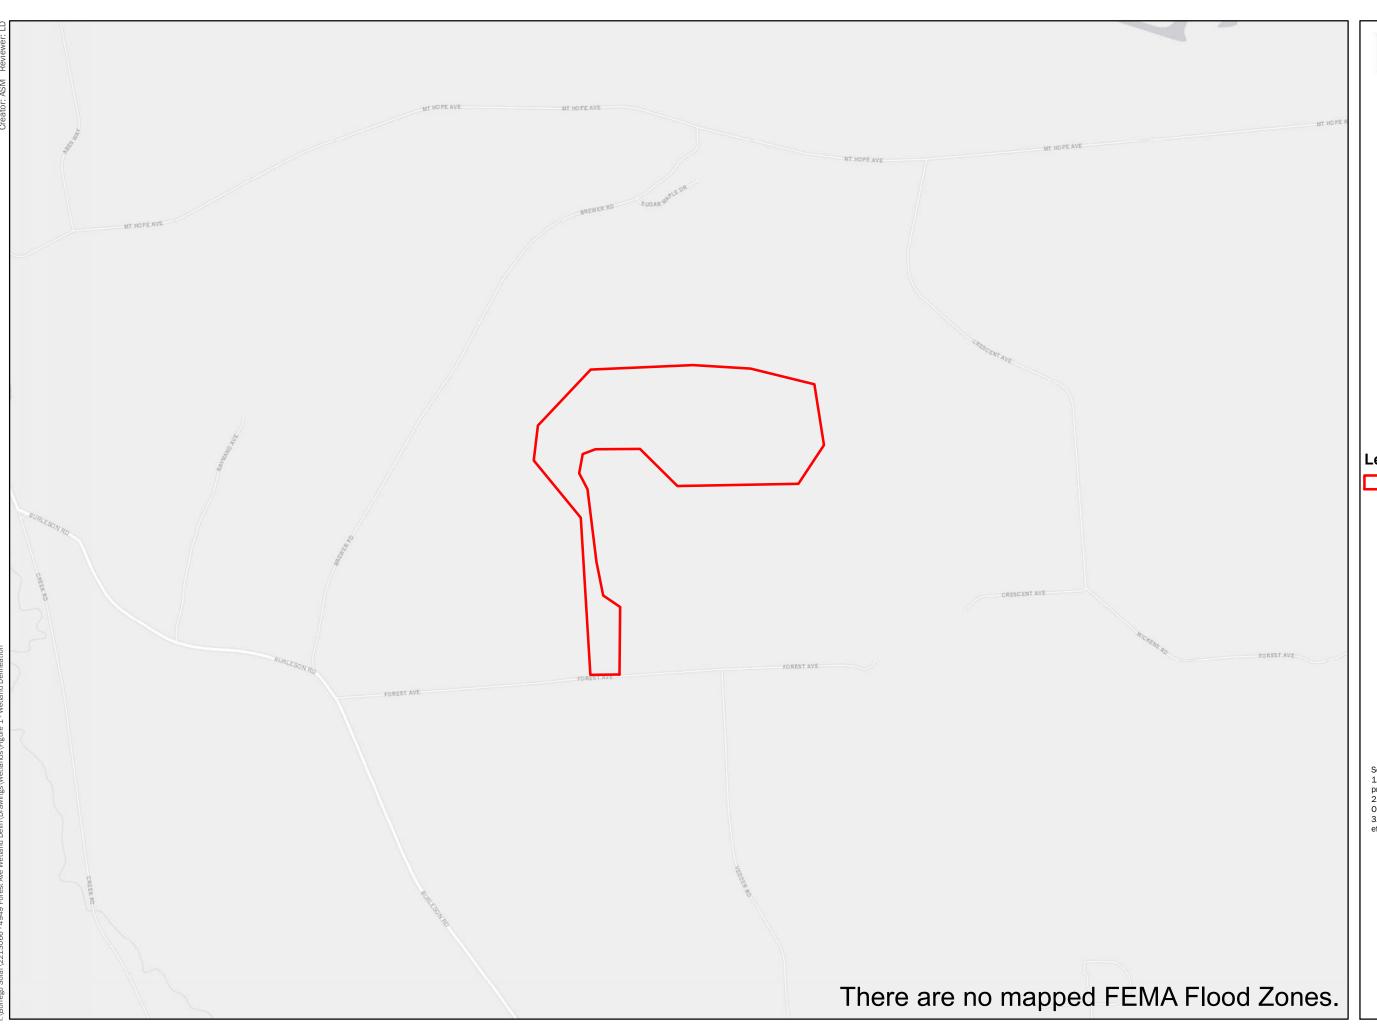
FIGURE 4

FEMA mapping showed no 100-year flood zones associated with the Study Area (refer to Appendix A, Figure 4). The closest flood zone is located approximately 9,255 feet northwest of the Study Area.

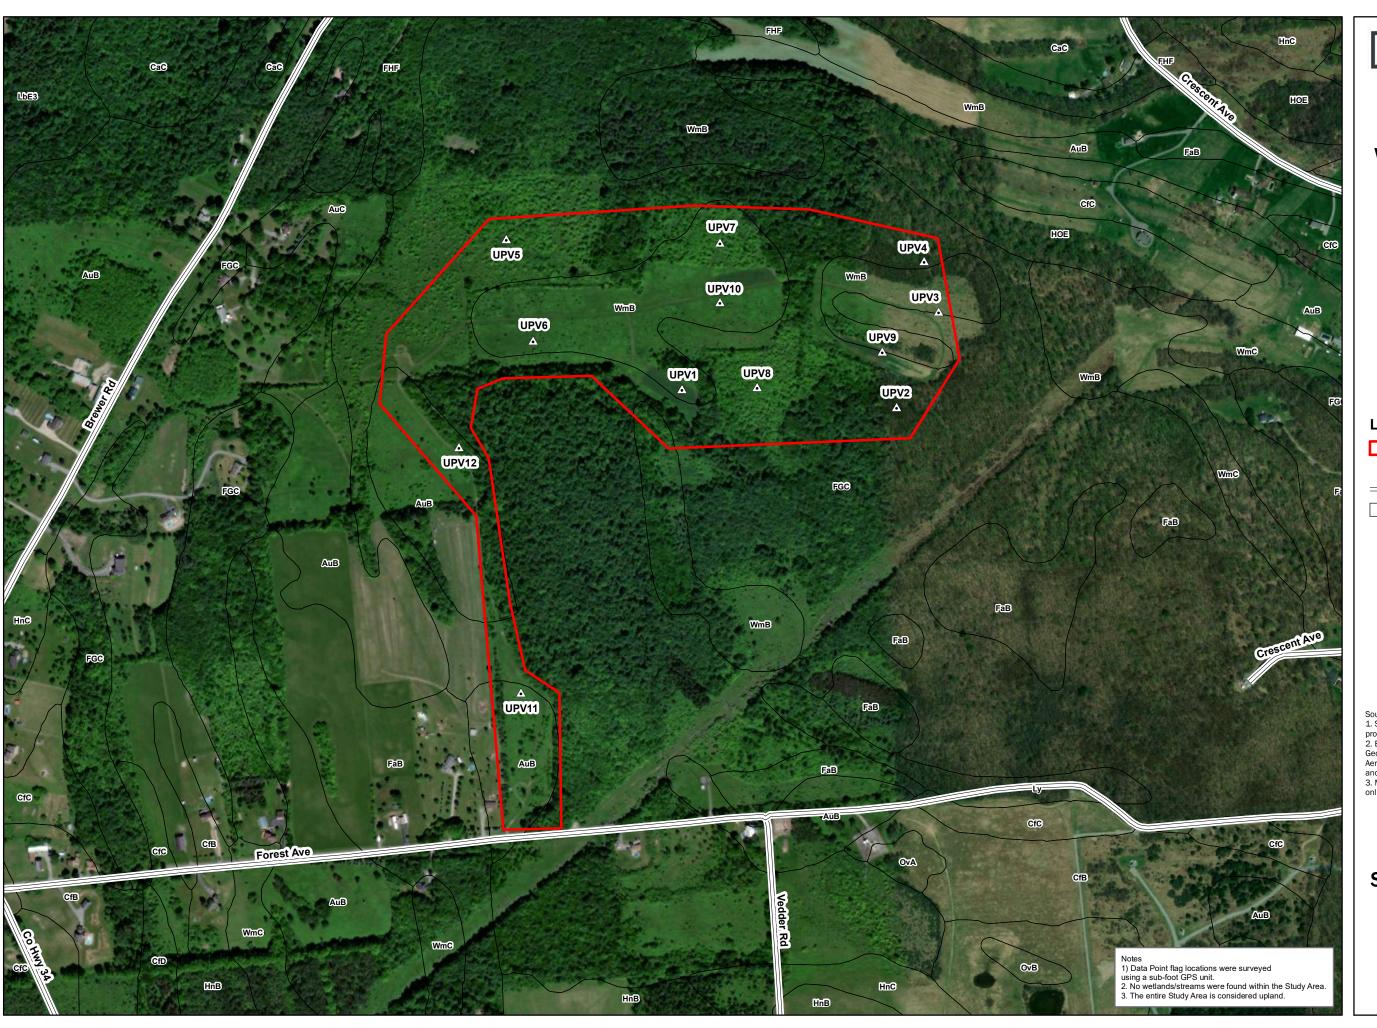
LaBella field staff did not identify wetlands or streams within the Study Area (See Appendix A, Figure 5). The Study Area consists of open field and forested upland habitats. These habitats lack wetland hydrology and hydric soils.

No wetlands or stream were identified within the Study Area. Please refer to Data Forms provided in Appendix B and Figure 5 provided in Appendix A.

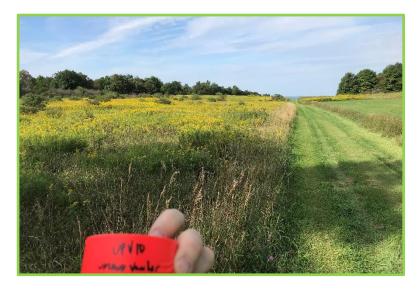
Upland communities within the Study Area primarily consist of open field and forested areas. Dominant species in the upland areas consisted of cat grass (*Dactylis glomerata*), smooth brome (*Bromus inermis*), sugar maple (*Acer saccharum*), white ash (*Fraxinus americana*), downy hawthorn (*Crataegus mollis*), tatarian honeysuckle (*Lonicera tatarica*), wrinkleleaf goldenrod (*Solidago rugosa*), wild basil (*Clinopodium vulgare*), bird's-foot trefoil (*Lotus corniculatus*), purple starthistle (*Centaurea calcitrapa*), American elm (*Ulmus americana*), red hickory (*Carya ovalis*), red trillium (*Trillium erectum*), and summer grape (*Vitis aestivalis*).

Representative view of upland areas

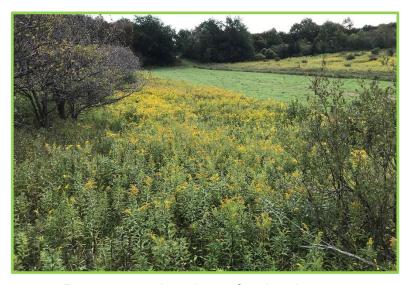
Representative view of upland areas

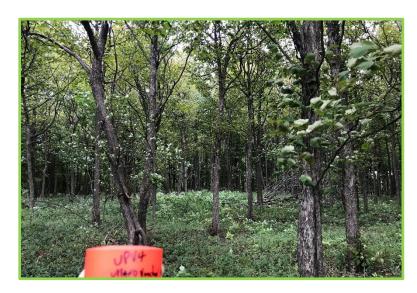
Representative view of upland areas
